MSC-MEPC.3/Circ.5  
22 July 2021

**CASUALTY-RELATED MATTERS\***  
**REPORTS ON MARINE CASUALTIES AND INCIDENTS**

# LESSONS LEARNED

FROM ACCIDENTS INVOLVING MERCHANT, FISHING, AND SPORT VESSELS,  
AND PORT, DIVING, AND AQUACULTURE OPERATIONS.

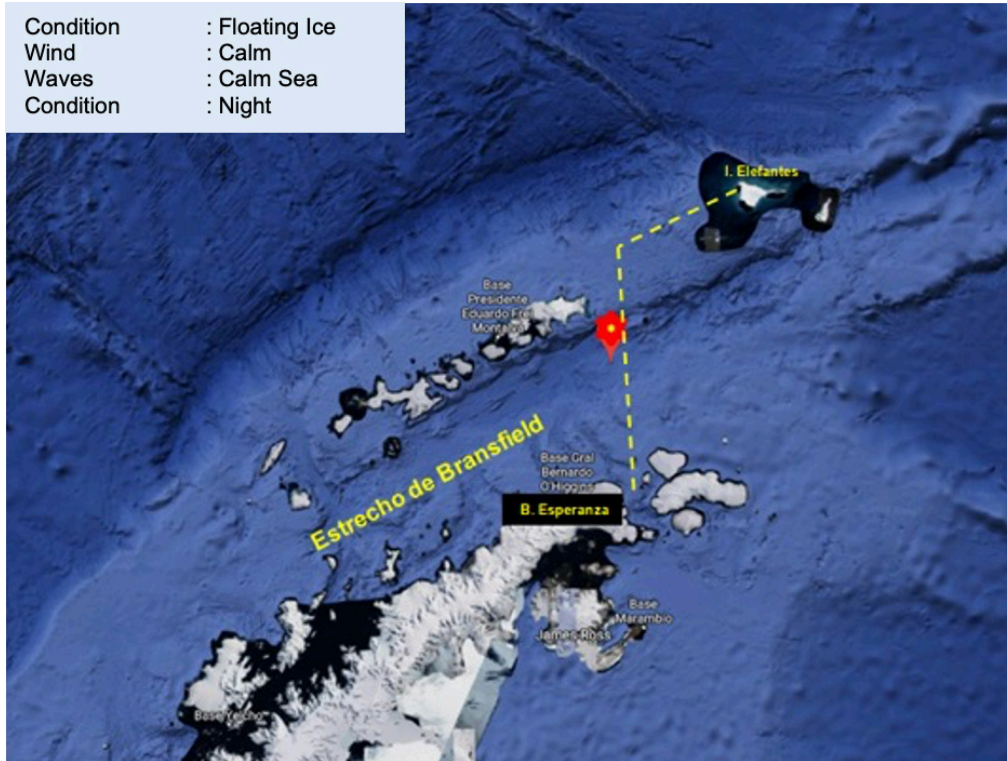
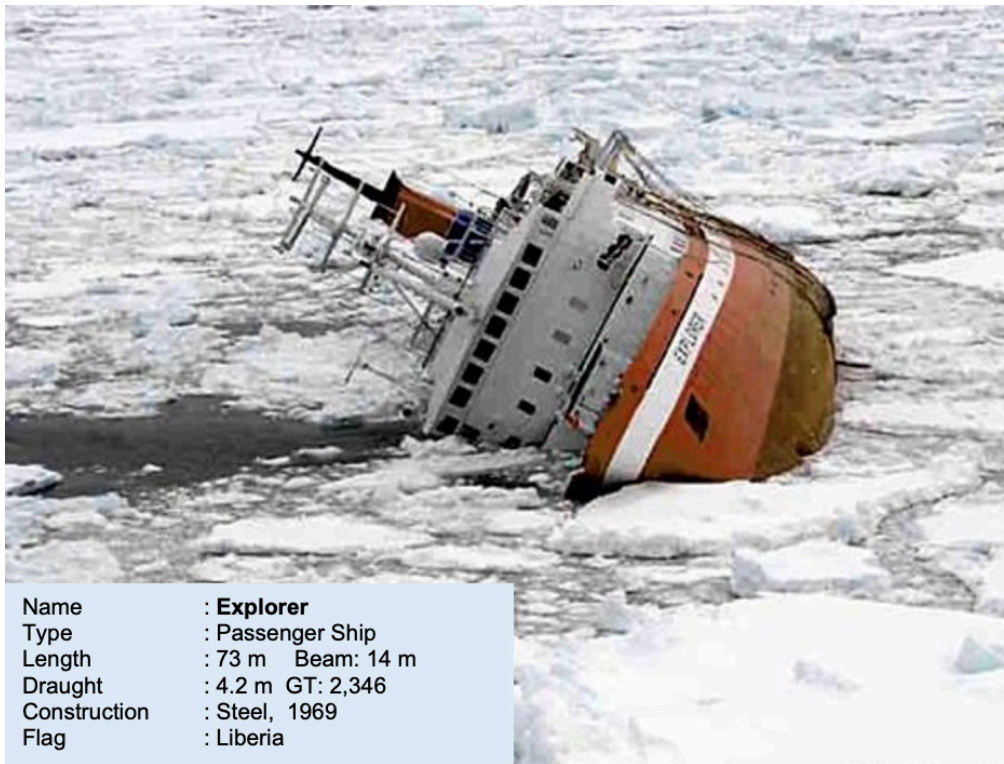
On 23 November 2007, the Liberian-flagged passenger cruise **MV Explorer**, with 154 people on board, sunk in the Bransfield Strait due to **uncontrollable leaks**, caused by damage to the quickwork, when they **crossed a floating ice zone**. The bridge team assessed the ice as “first year ice”, but among them there were floebergs, much harder mass of ice. The ship had 28 years of service and an **ICE-A1A1 class hull**, but as it was not calibrated, some plates may have been weakened.

The flooding of an electrical panel caused a **blackout that shut down all the pumps**, including the portable ones that were installed, so the flooding became uncontrollable. This, added to the low temperature of the water, caused hypothermia in the crew and the panels covering the hull made it difficult to find the failure.

**The abandonment was effective**, it started early and in fair weather conditions, which minimized the impact of the **failure of the lifeboats engines** that did not start due to the low temperature. All the passengers and the crew were rescued unharmed by other ships and finally sheltered in Chilean and Uruguayan Antarctic bases. The ship sank in 1300 metres of water with 210 m3 of diesel oil in the tanks.

3.- *Ships operating in Antarctica require procedures, equipment, and crew training on damage control, to successfully address hull damage and seawater floodings at low temperature.*

4.- *Masters of ships with leaks must order to prepare the abandon ship procedure early to prevent floodings from becoming uncontrollable.*

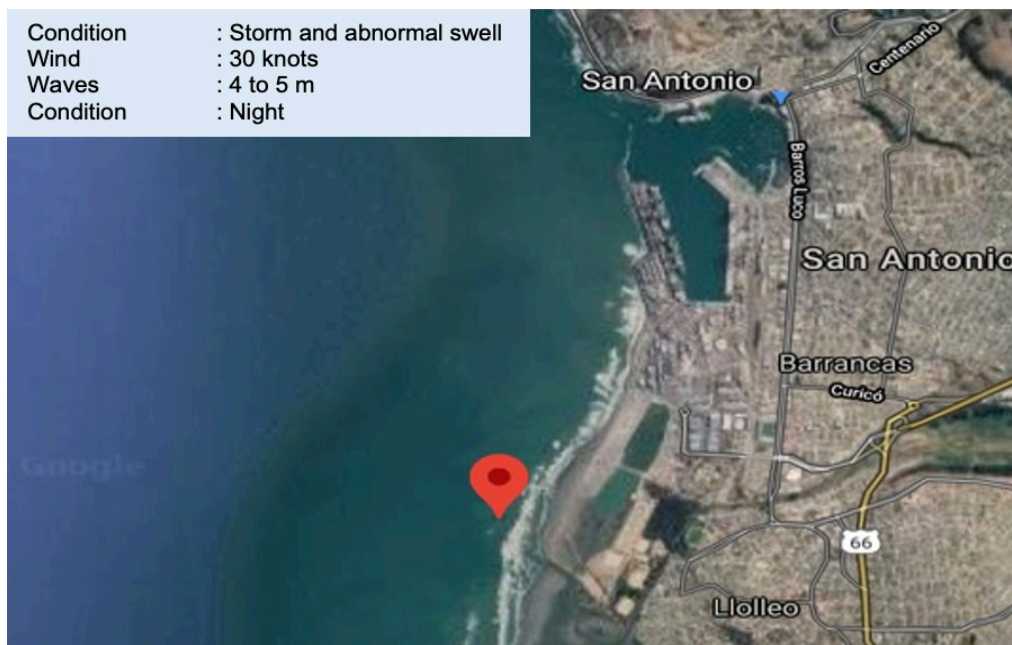
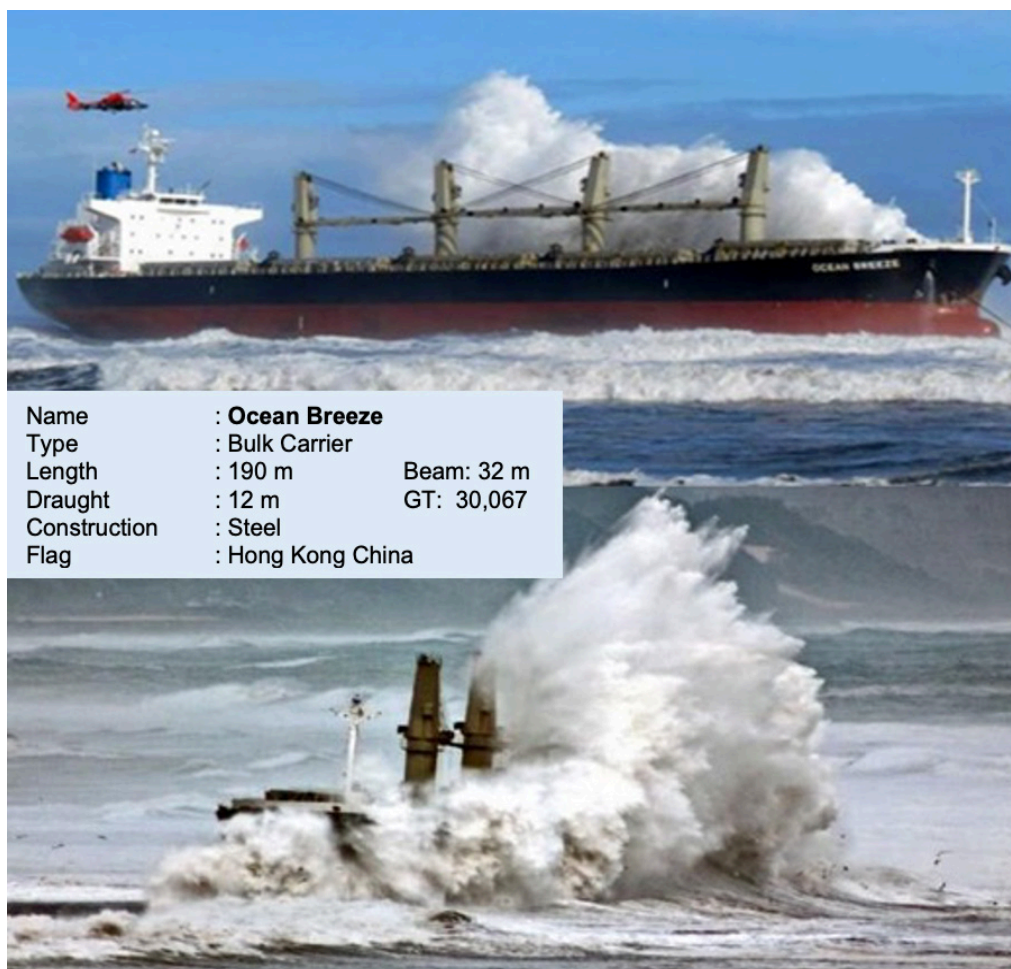
Local guidelines, the sailing directions, and the Guide to Port Entry recommended that, **under bad weather, ships riding at anchor must set sail**, as the holding ground was bad and there were experiences from similar groundings. The Master had instructed to notify him in case of dragging.

The investigation showed a **fatigue condition of the Master and the watch officer**, who had been on sea service for 8.5 and 11 months straight, which would explain the delay in their reaction under a high-risk situation. The ship and its grain cargo were declared a total loss and its dumping generated a high cost.

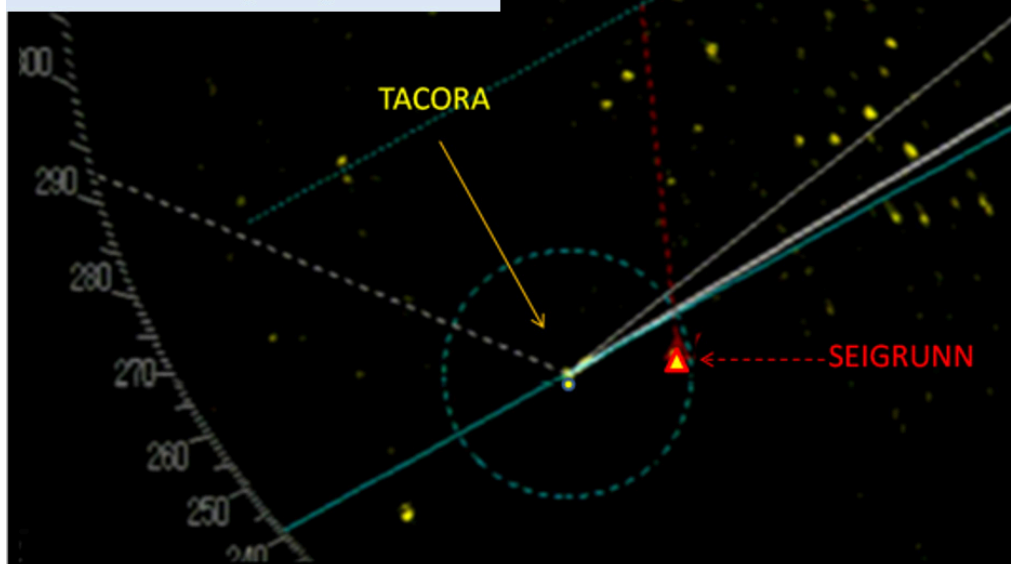
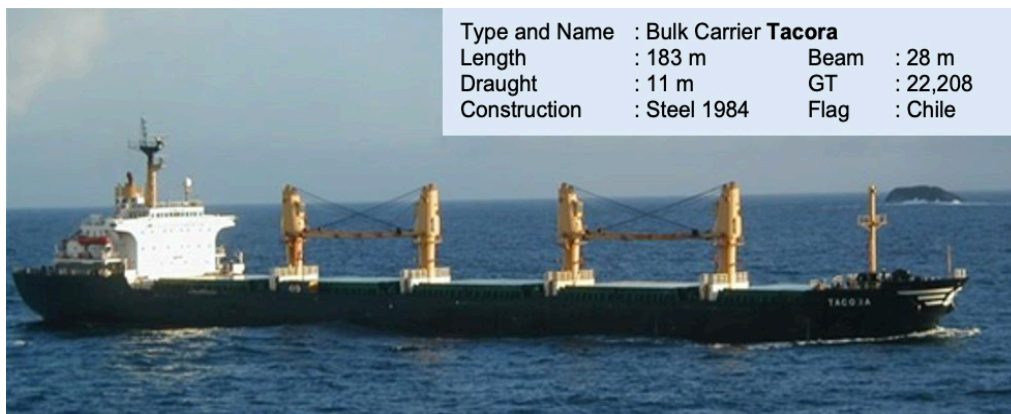
In June 2012, the bulk carrier **Tacora** and the Chilean-flagged wellboat **Seigrunn** collided while navigating the Gulf of Corcovado. Both ships resulted damaged, with no injured people or pollution. **Both ships detected each other** visually and by radar long beforehand, and always had enough open waters to perform the crossing situation provided in **Rule 15 of the International Regulations for Preventing Collisions at Sea**, which indicates that the bulk carrier should have slowed down and steered to starboard to avoid crossing ahead of the wellboat coming from starboard. When the wellboat noticed the imminent collision, they told the Tacora off over voice communication and informed they would slow down to let the bulk carrier cross.

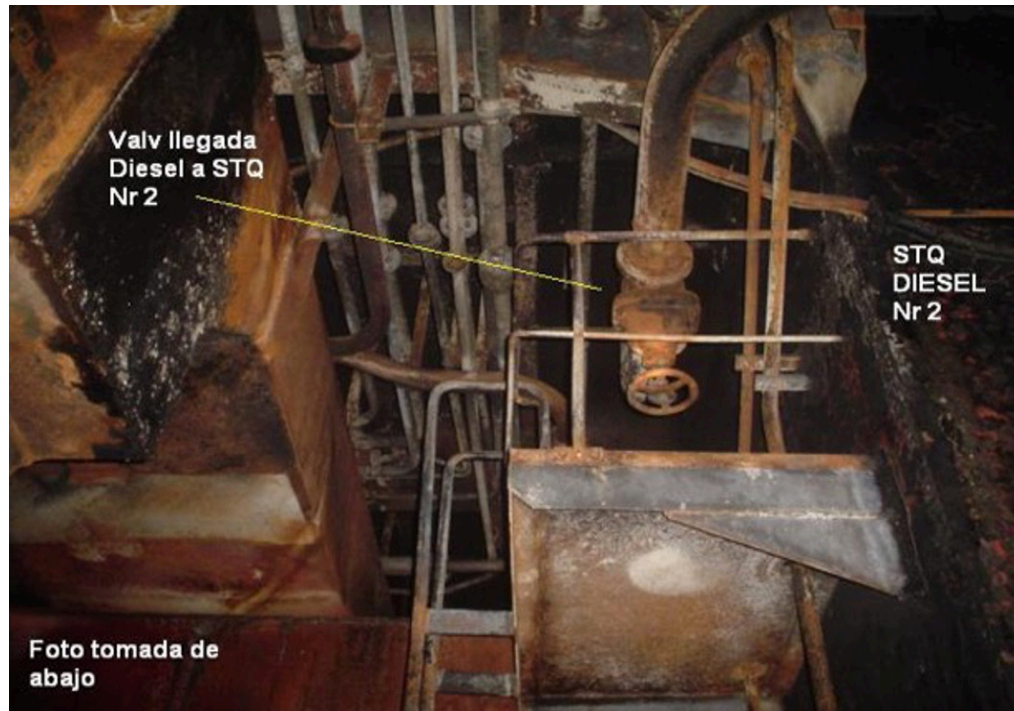
In the morning of 16 February 2008, the car carrier **Río Blanco** spilled oil to the sea while loading in Santos, Brazil, before departing for Chile. Hours later, there was a fire in its engine room, resulting in the death of 2 Officers by suffocation and 1 crew member by burning.

**The spill** was due to the wrong alignment of the valves, which overflowed while interconnecting diesel and fuel oil tanks. The failure was not detected because the automatic sounding system was defective and there were no instructions to manually control the level in all tanks, as the safety procedure indicated.

5.- *Weaknesses in the ways of escape of the engine room must be fixed previously. The RIO BLANCO did it late, installing a ladder and a hatchway to the upper deck, which could have prevented deaths and damage.*

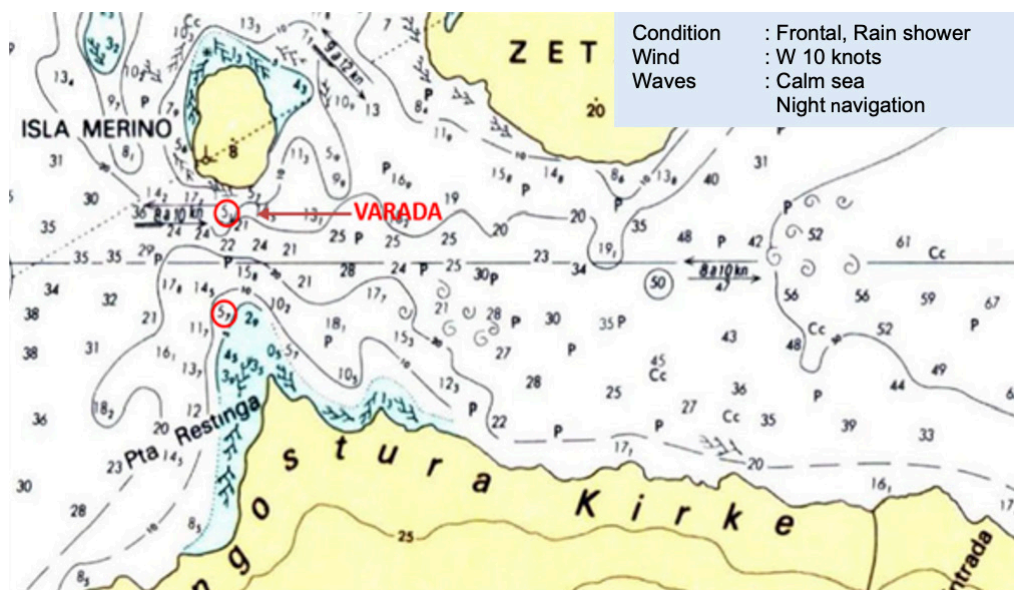
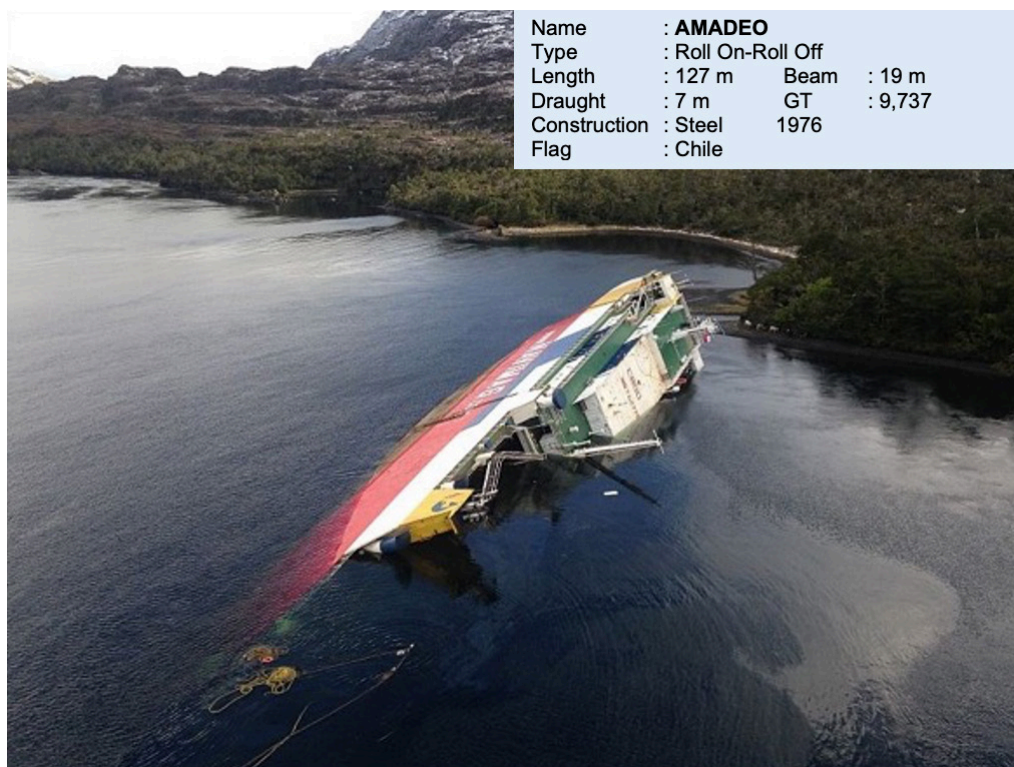
The navigation of Kirke Narrows **did not comply with the recommendations of the Sailing Directions of the Chilean Coast**. When the ship navigated against the current and far from the time of stand, the Master was forced to steer at large rudder angles, in the middle of dangerous overfalls due to the strong current.

Due to the fast flooding and the uncontrollable heeling caused by the leaks, the Master **declared general average and grounded the ship on the coast**, which did not prevent the total loss of the ship and its cargo or the sea pollution from the oil. This resulted in a high-cost wreckage removal.

4.- *Roll On-Roll Off vessels built before October 1989 were designed with holds that do not have enough cross subdivision, which makes it difficult to stop leaks in damage condition. Hence, they require plans and crew that are highly effective in controlling damage.*

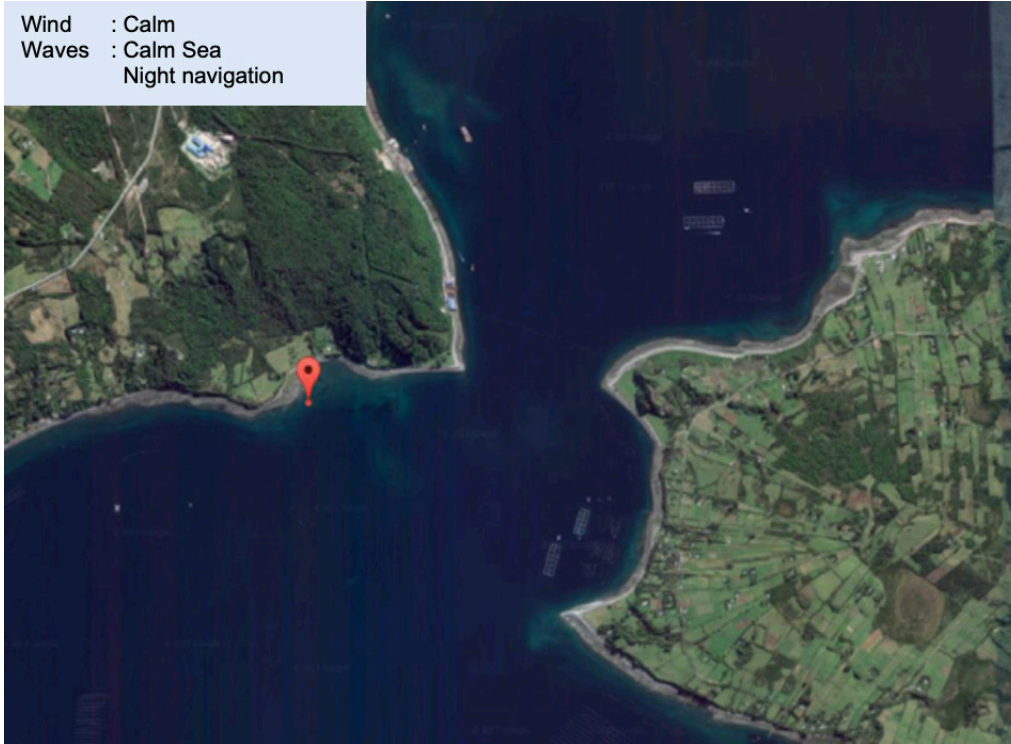
On the morning of 5 February 2015, The **MV Skorprios II**, with 89 passengers and 23 crew members onboard, **grounded in Santo Domingo point**, while navigating from Castro to Puerto Montt **under good weather conditions**. Passengers were rescued by ships of the Chilean Navy and there were no people injured.

**The ship refloated with the next tide**, without damages to the hull or pollution.

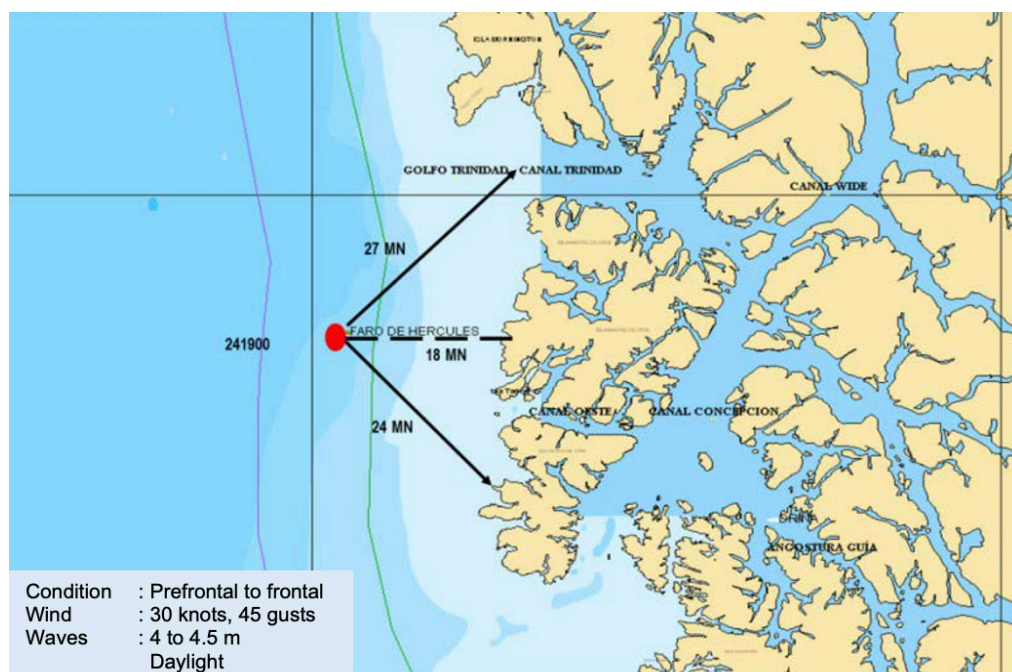
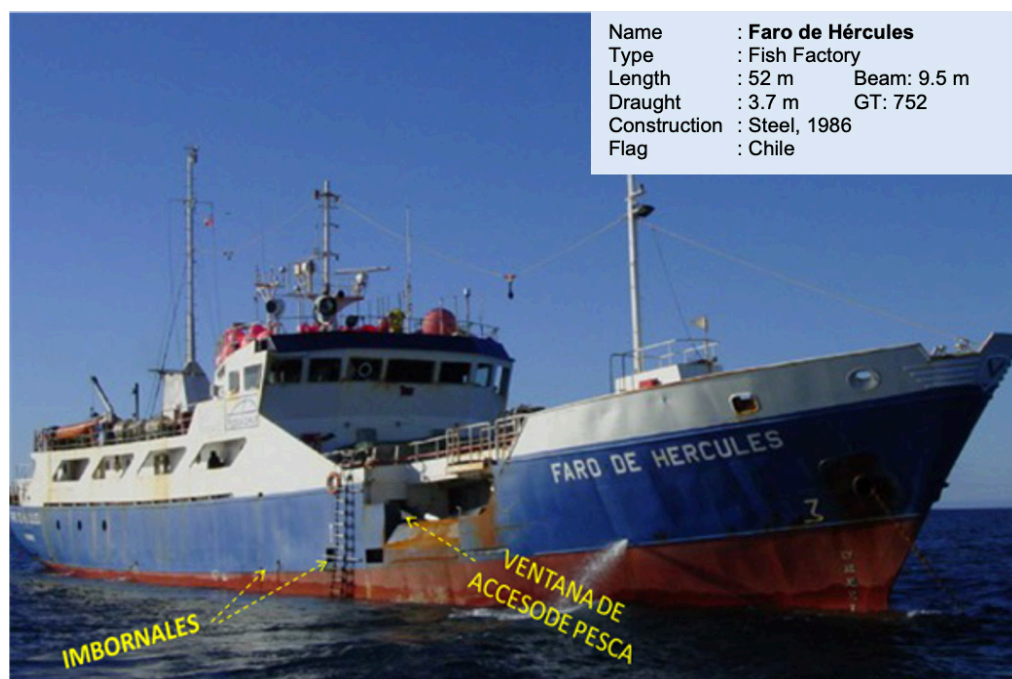
On 24 February 2011, the Chilean fish factory ship **Faro de Hércules** heeled, capsized, and sank when fishing in Trinidad Gulf, with winds that reached 45 knots and 4 to 4.5 m waves, resulting in 4 people missing and 38 rescued.

The initial **heeling** was due to the wind against the side, added to the speed of the ship, which increased the effect of the swell and the leaking water, which in turn increased the heeling and the free surface. **Water tightness** in the factory was necessary and a known risk, since another similar ship of the Company had capsized when its factory flooded. Even then, there were no

**Risk management:** With a 50% of the factory flooded, the ship would capsize. The Master took 25 minutes to notice that the heeling was not due to the wind. This made the management of the flooding unsuccessful, as a great volume of water had entered, and they were unable to stop the leak. **The order to abandon ship** was not given, despite the considerable heeling and uncontrollable flooding. The accurate perception of danger made the crew activate and board the lifeboats, preventing more deaths. At a 90° heel, the DISTRESS signal was activated, and a VHF radio was taken on board a lifeboat.

2.- *Procedures to establish and maintain water tightness are imperative, especially under bad weather conditions, and every crew member is responsible for them.*

4.- *Under uncontrolled conditions, and especially when there is risk of sinking, the Master has the obligation to formally alert the crew and the Maritime Authority and give the order to prepare the abandonment of the ship. Abandon ship orders are easier to cancel than to improvise a successful abandonment.*

5.- *The activation of the DISTRESS signal must not be delayed until the last moment, as the emergency itself may prevent its use. Portable VHF equipment are useful to communicate with SAR teams.*
