MSC-MEPC.3/Circ.5  
22 July 2021

**CASUALTY-RELATED MATTERS\***  
**REPORTS ON MARINE CASUALTIES AND INCIDENTS**

# LESSONS LEARNED

FROM ACCIDENTS INVOLVING MERCHANT, FISHING, AND SPORT VESSELS,  
AND PORT, DIVING, AND AQUACULTURE OPERATIONS.

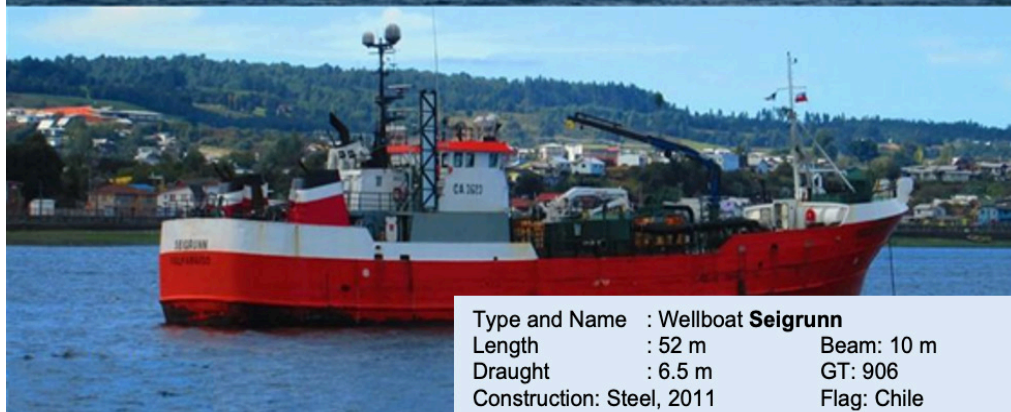
Type and Name : Wellboat **Seigrunn**  
Length : 52 m Beam: 10 m  
Draught : 6.5 m GT: 906  
Construction: Steel, 2011 Flag: Chile

In June 2012, the bulk carrier **Tacora** and the Chilean-flagged wellboat **Seigrunn** collided while navigating the Gulf of Corcovado. Both ships resulted damaged, with no injured people or pollution. **Both ships detected each other** visually and by radar long beforehand, and always had enough open waters to perform the crossing situation provided in **Rule 15 of the International Regulations for Preventing Collisions at Sea**, which indicates that the bulk carrier should have slowed down and steered to starboard to avoid crossing ahead of the wellboat coming from starboard. When the wellboat noticed the imminent collision, they told the Tacora off over voice communication and informed they would slow down to let the bulk carrier cross.

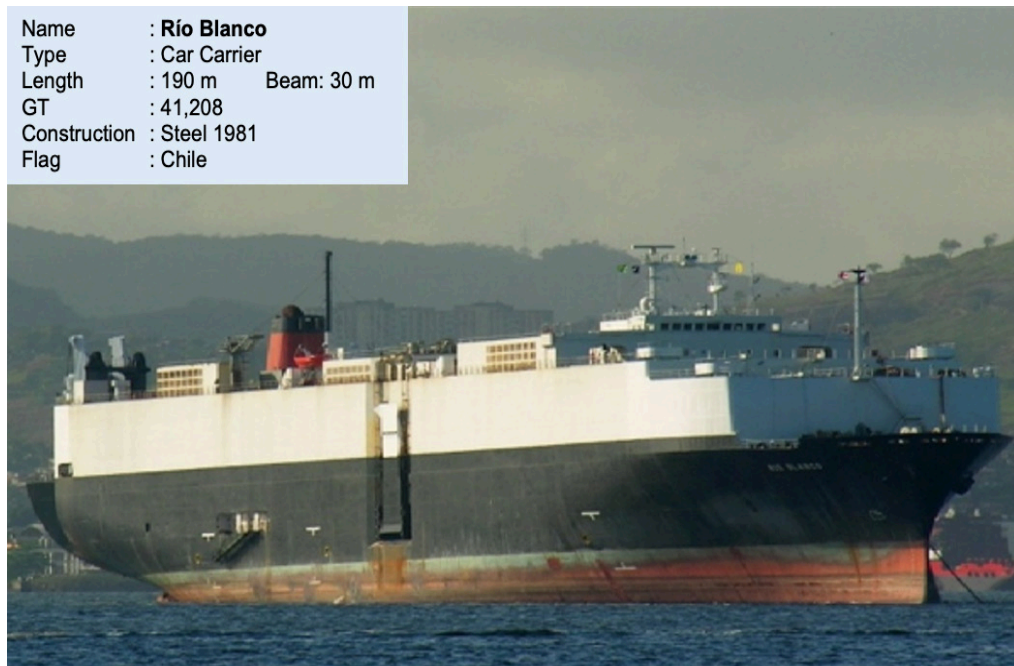
Name : Río Blanco  
Type : Car Carrier  
Length : 190 m Beam: 30 m  
GT : 41,208  
Construction : Steel 1981  
Flag : Chile

In the morning of 16 February 2008, the car carrier **Río Blanco** spilled oil to the sea while loading in Santos, Brazil, before departing for Chile. Hours later, there was a fire in its engine room, resulting in the death of 2 Officers by suffocation and 1 crew member by burning.

**The spill** was due to the wrong alignment of the valves, which overflowed while interconnecting diesel and fuel oil tanks. The failure was not detected because the automatic sounding system was defective and there were no instructions to manually control the level in all tanks, as the safety procedure indicated.

5.- *Weaknesses in the ways of escape of the engine room must be fixed previously. The RIO BLANCO did it late, installing a ladder and a hatchway to the upper deck, which could have prevented deaths and damage.*

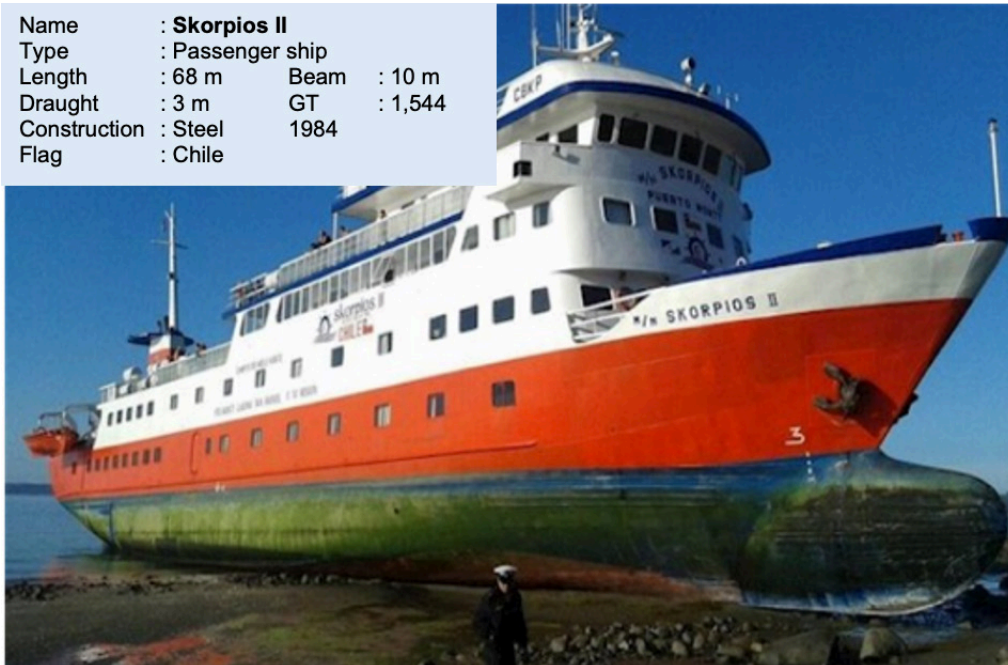
Name : **Skorpios II**  
Type : Passenger ship  
Length : 68 m      Beam : 10 m  
Draught : 3 m      GT : 1,544  
Construction : Steel      1984  
Flag : Chile

On the morning of 5 February 2015, The **MV Skorprios II**, with 89 passengers and 23 crew members onboard, **grounded in Santo Domingo point**, while navigating from Castro to Puerto Montt **under good weather conditions**. Passengers were rescued by ships of the Chilean Navy and there were no people injured.

**The ship refloated with the next tide**, without damages to the hull or pollution.

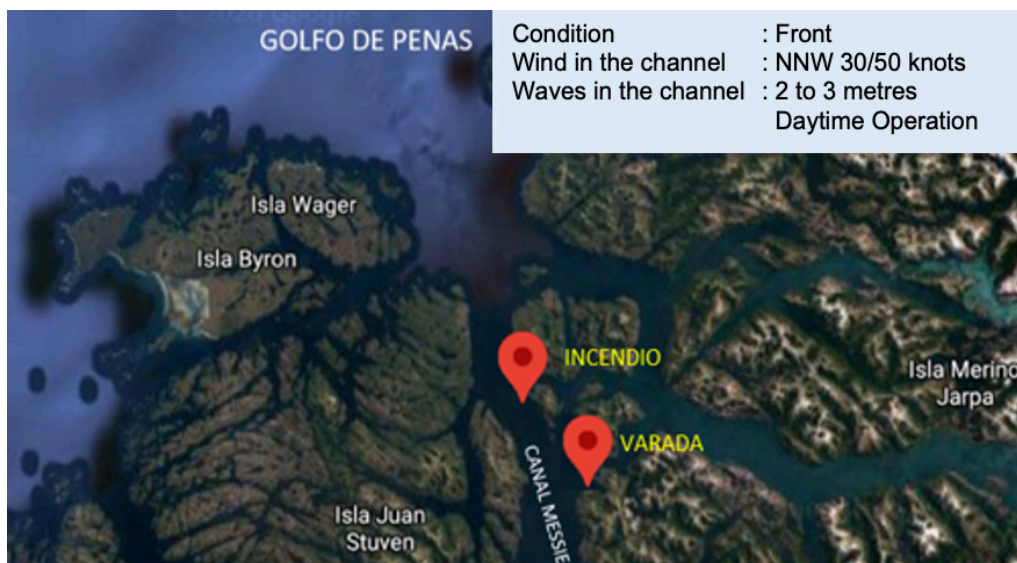
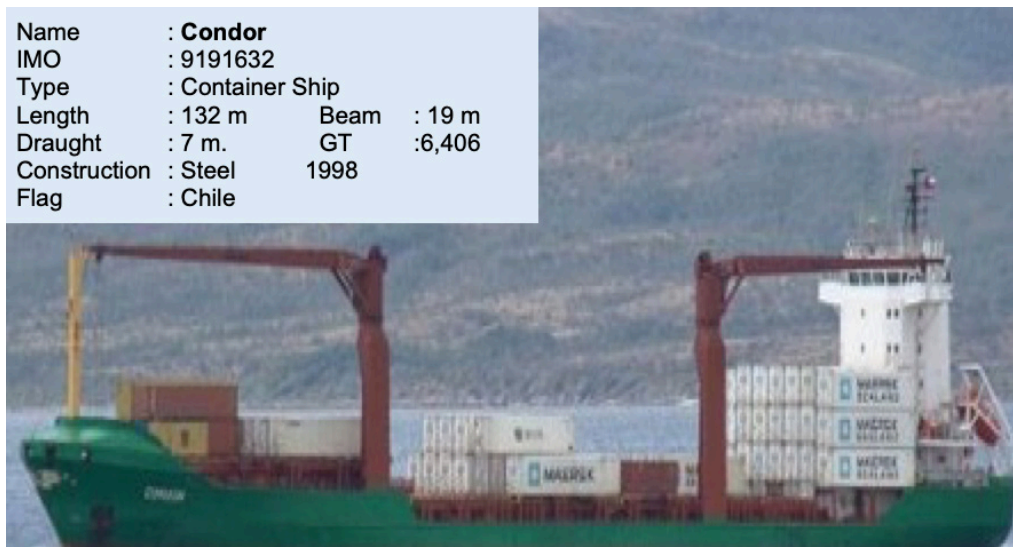
Name : **Condor**  
IMO : 9191632  
Type : Container Ship  
Length : 132 m Beam : 19 m  
Draught : 7 m. GT : 6,406  
Construction : Steel 1998  
Flag : Chile

leaks in the engine room.

4.- *The hot spots of any system must be thermally isolated to prevent the inflammation of possible fuel leaks.*

5.- *Any small fuel leak will eventually lead to a fire and that is why they should be prevented.*

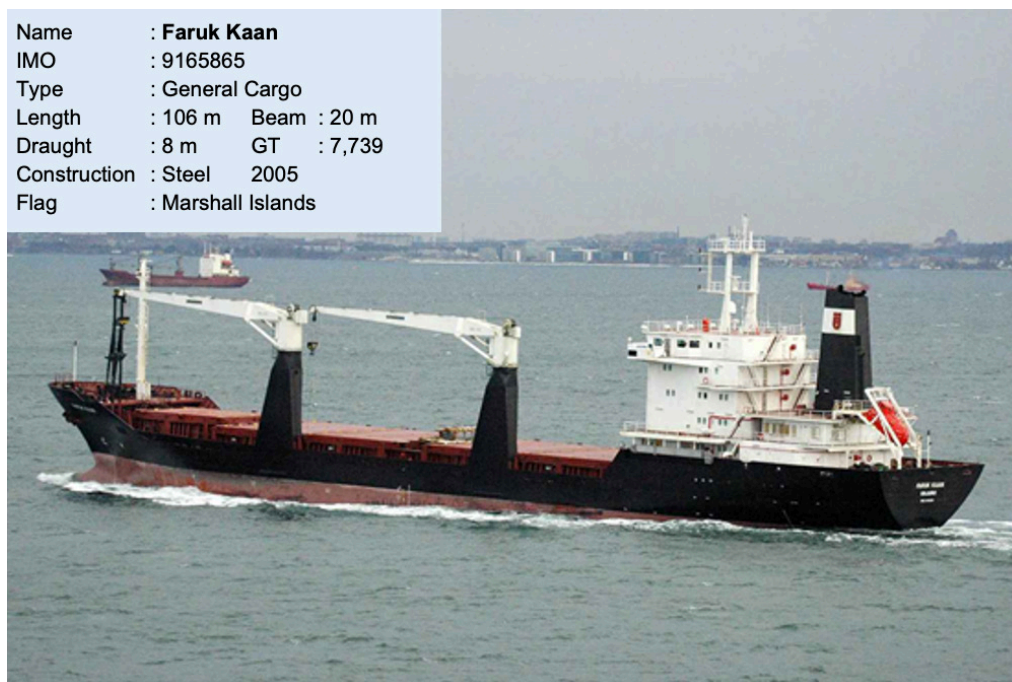
## **GROUNDING OF CARGO MV AT ANCHOR, IN PUERTO CISNES**

To be able to sleep, they programmed some nights with the vessel riding at anchor and the Master kept watch until midnight and then was relieved by the **Deck officer who was authorized to sleep**. Such a decision caused a dangerous condition, **as the bridge was unattended** and without the capacity for a prompt response in case of dragging or any other potential risk when

The anchorage point chosen was a beach area close to the mouth of a river, and because of the changing conditions, sounding information was not available, making this area not suitable for navigation of large vessels, and especially not for riding at anchor.

The grounding did not cause injury to people, or damage to the environment or the vessel, which was refloated at high tide.

5.- Due to the risk of grounding, large ships should not navigate or stay in areas where there is no sounding information available, as it is the only way to know how much water the ship will have under the keel under low tide conditions.

6.- Ships are fitted with echo-sounding devices with shallow water alarms, which are an effective tool to prevent ships from running aground, but only if it is activated correctly.

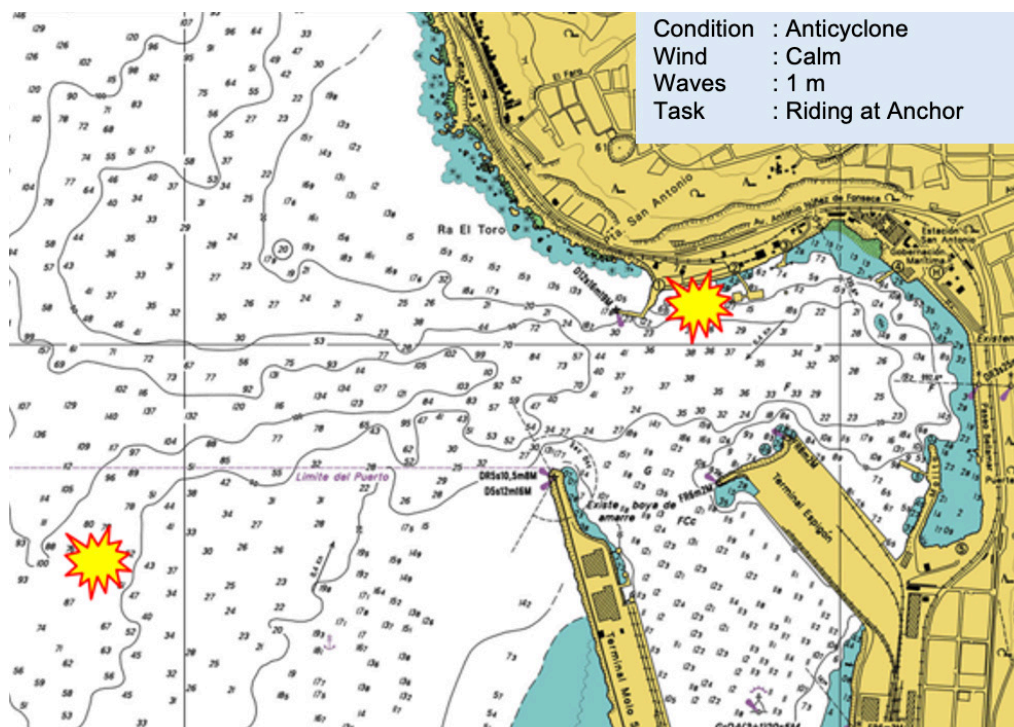
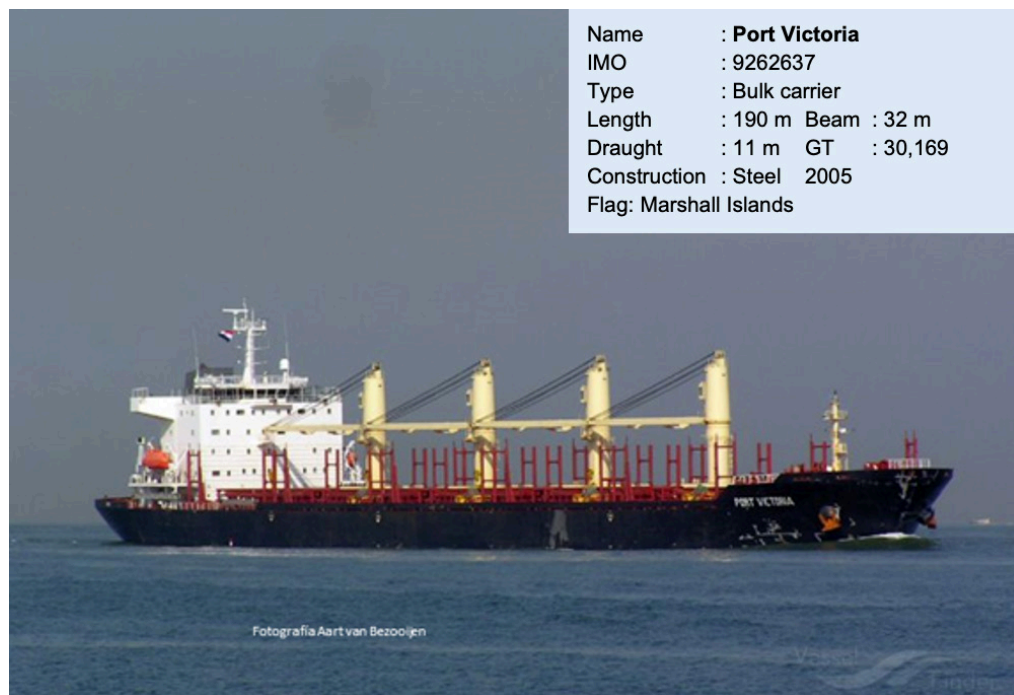
## **FIRE IN CARGO HOLD OF A BULK CARRIER, IN SAN ANTONIO**

4.- *Fermentation due to the activity of fungus and mould in the cereal mass inside a bulk storage, causes an insufficient natural circulation of air among grains, unable to liberate the heat produced, and due to the low specific heat, temperature can reach very high levels.*

5.- *To avoid spontaneous combustion of vegetable grains stored in bulk, it is vital to adopt measures at the moment of embarkation to avoid the presence of mould, fungus and additional water. During the navigation, humidity and temperature must be controlled.*

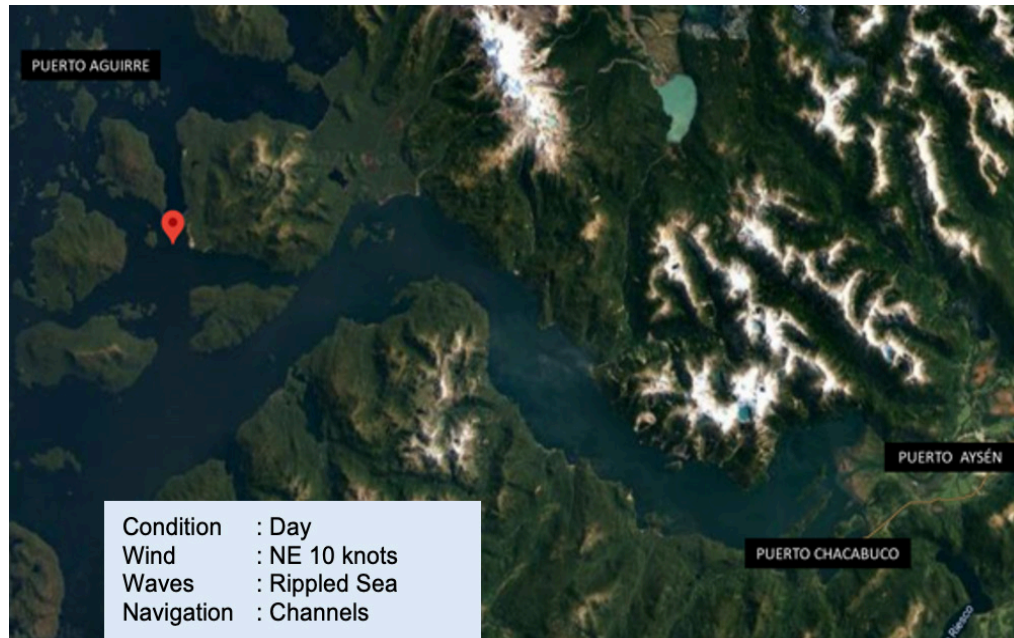
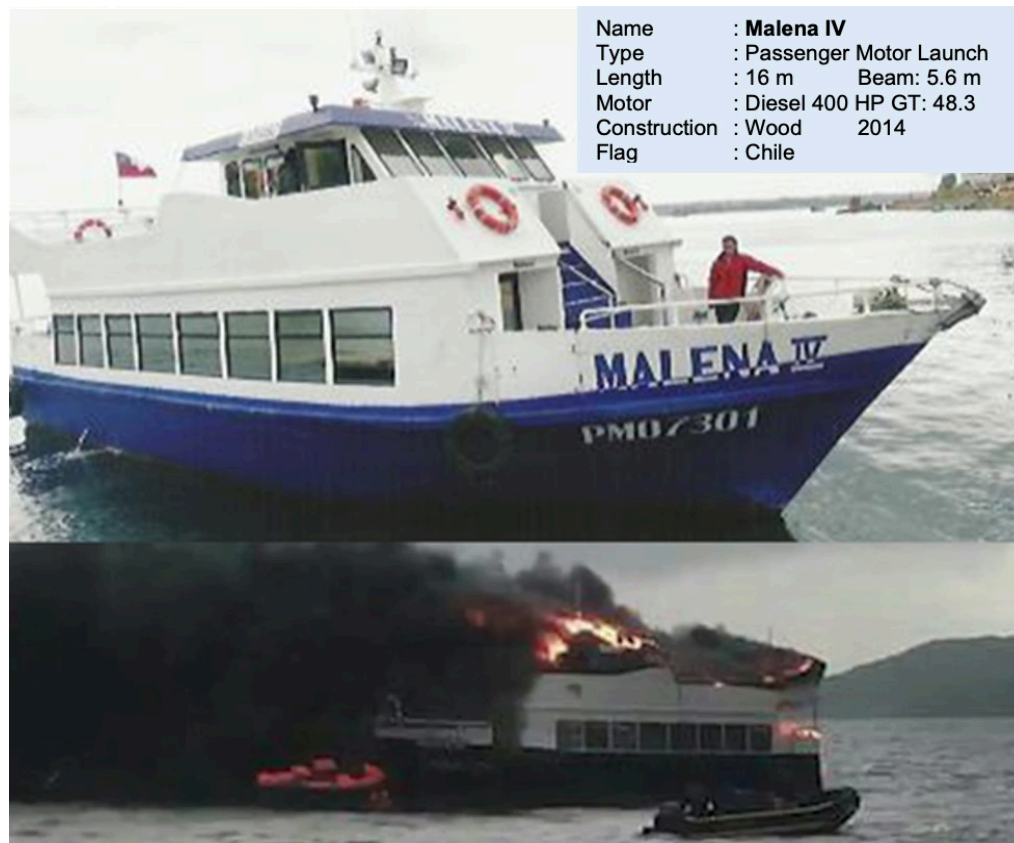
## **FIRE OF A PASSENGER LAUNCH, IN PILCOMAYO CHANNEL**

*4.- Typical narrowness of engine rooms in small vessels makes it difficult to enter the area and fight a fire from the inside. That is why it is advisable to install fire extinguishers both fixed and remotely activated, which help prevent oxygen from entering the area and fuelling the flames.*

*5.- Fire pump motors must be independent and placed outside engine rooms.*

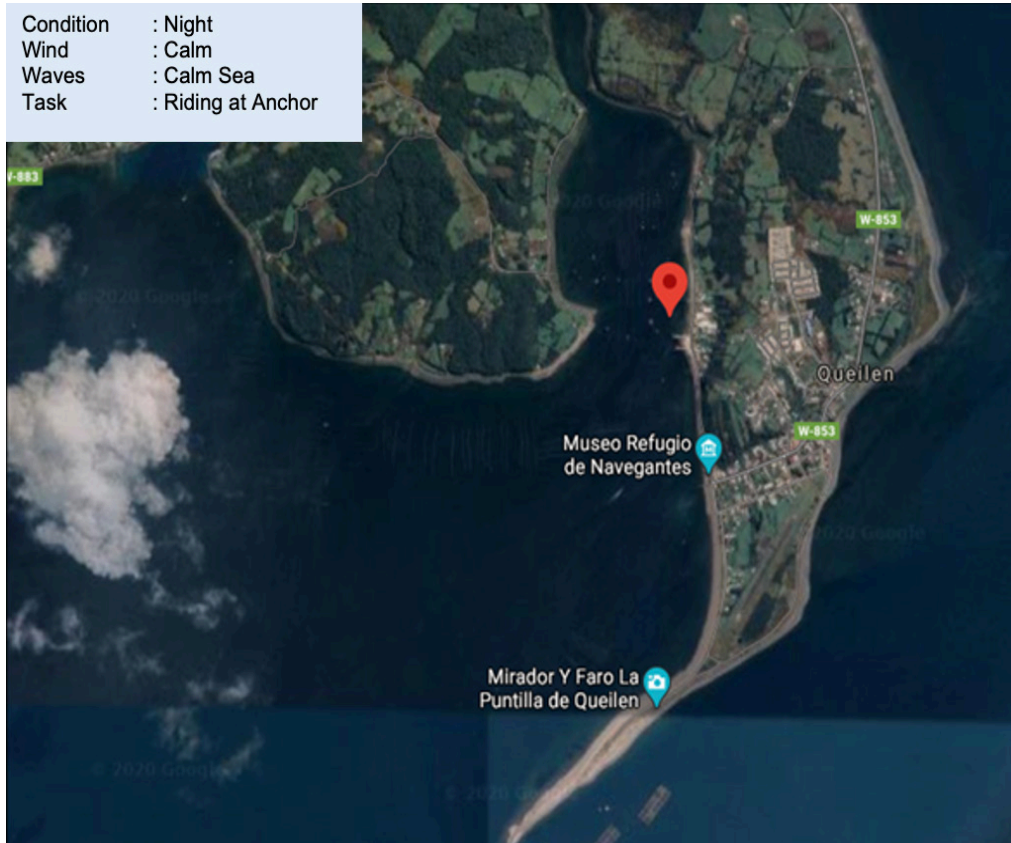
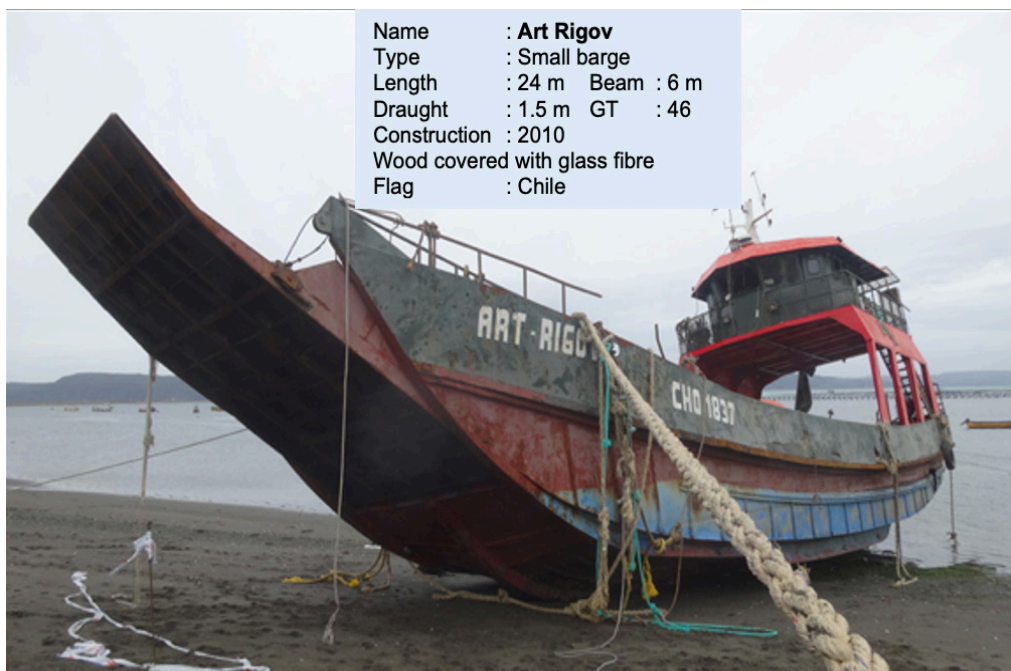
## **SINKING OF A SMALL VESSEL, MOORED IN QUEILEN**

The sinking caused a minor oil spill.

4.- *Transverse water tightness is fundamental to control damages to the hull. Watertight bulkheads must be checked, tested, and repaired regularly and thoroughly.*
